Risk Assessment – Kenton County

The Northern Kentucky Area Development District has developed a Risk Assessment for the Multi-Jurisdictional Hazard Mitigation Plan for the 8 counties and 53 incorporated cities within the planning region. Each of the 8 counties within the NKADD region has formed a Hazard Mitigation Planning committee and will consist of local officials from the county and city level, representatives from other organizations who offer expertise in specific areas, as well as members of the public.

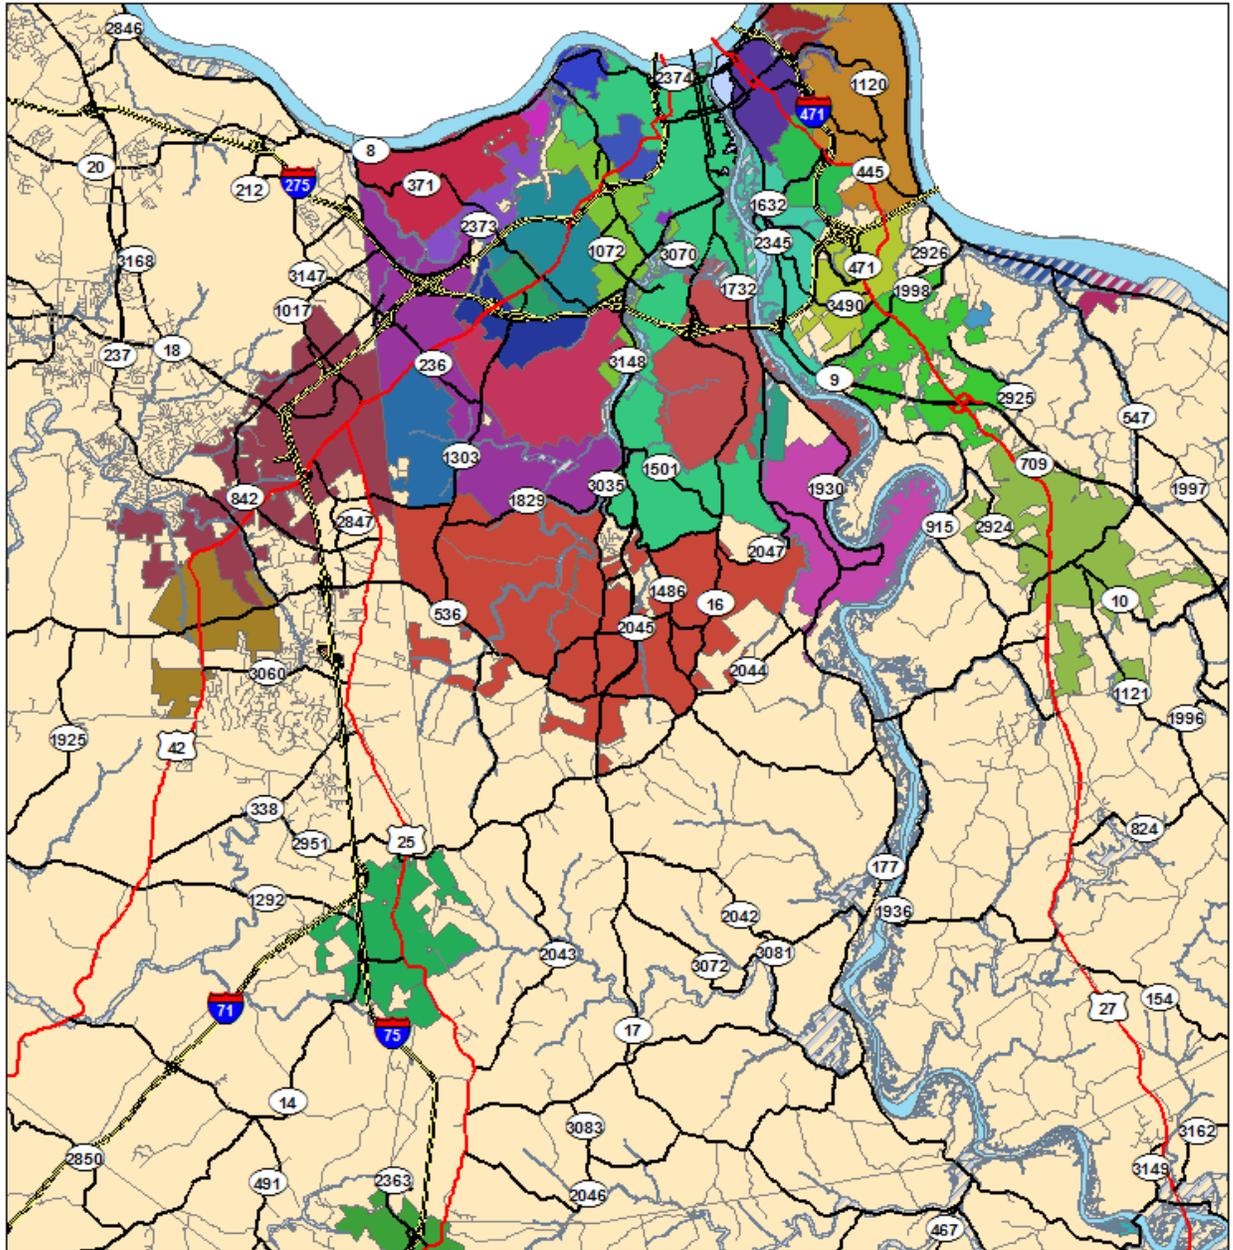
Kenton County Flood Hazard Area

The current FIRM maps for Kenton County are from 2013. Some areas have received Letter of Map Changes (LOMC), please go to FEMA's Map Service Center website for that information.

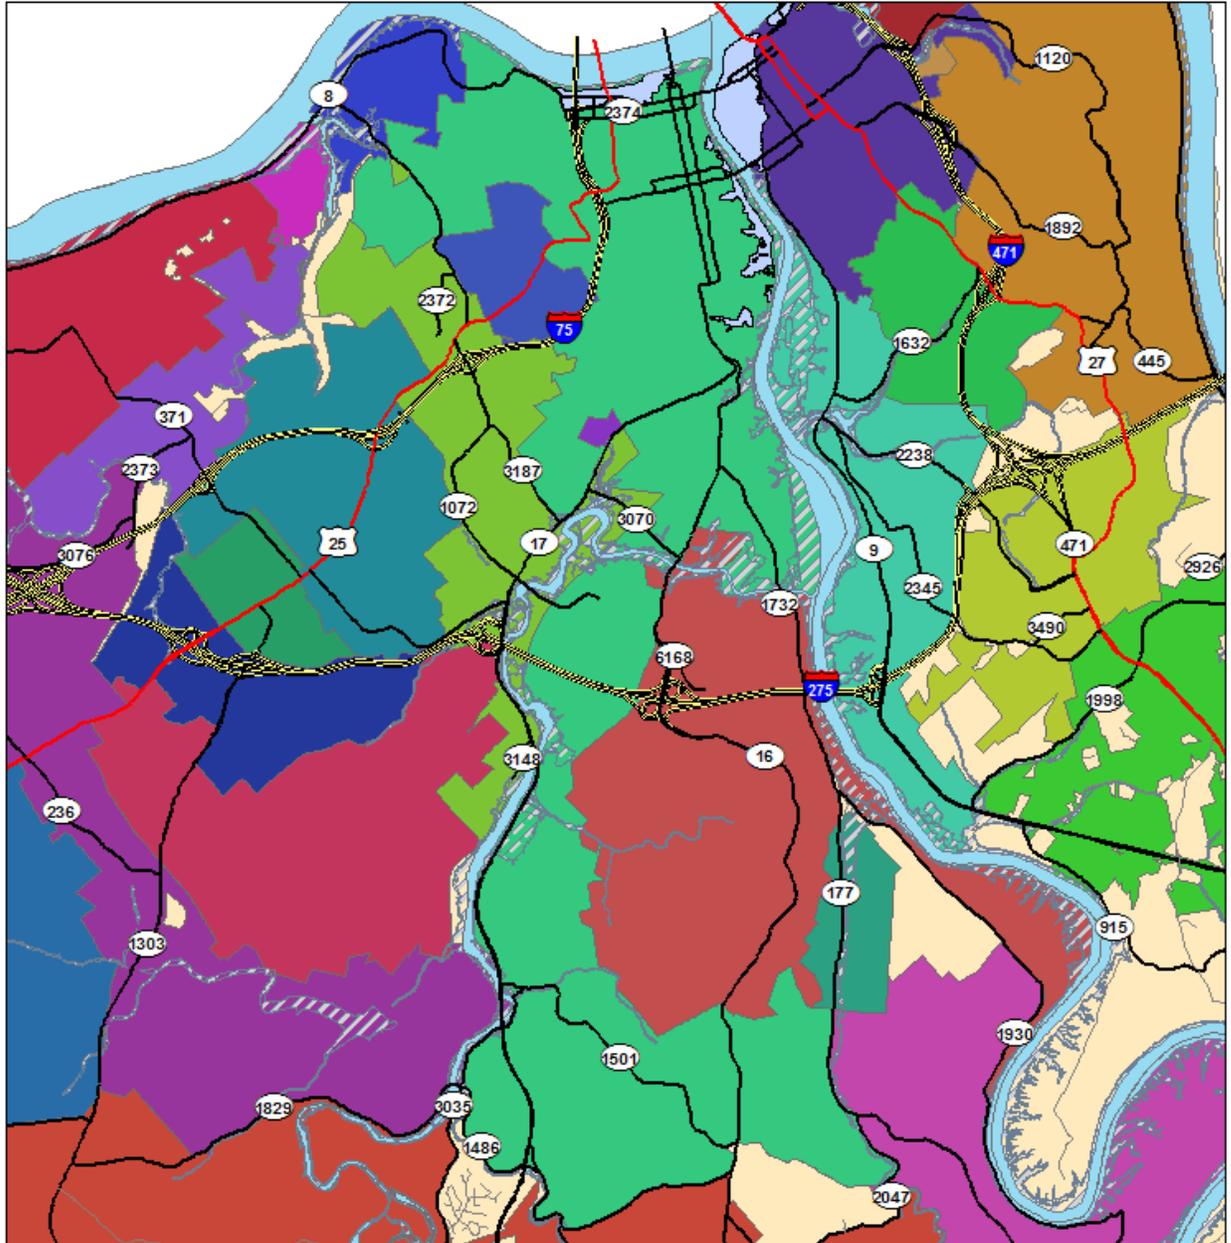
City of Covington Flood Hazard Area

- County Roads
- Interstate
- KY Highway
- US Highway
- Flood Hazard Area
- 0.2% Annual Chance Flood Hazard
- Reduced Flood Risk Due to Levee
- Floodway

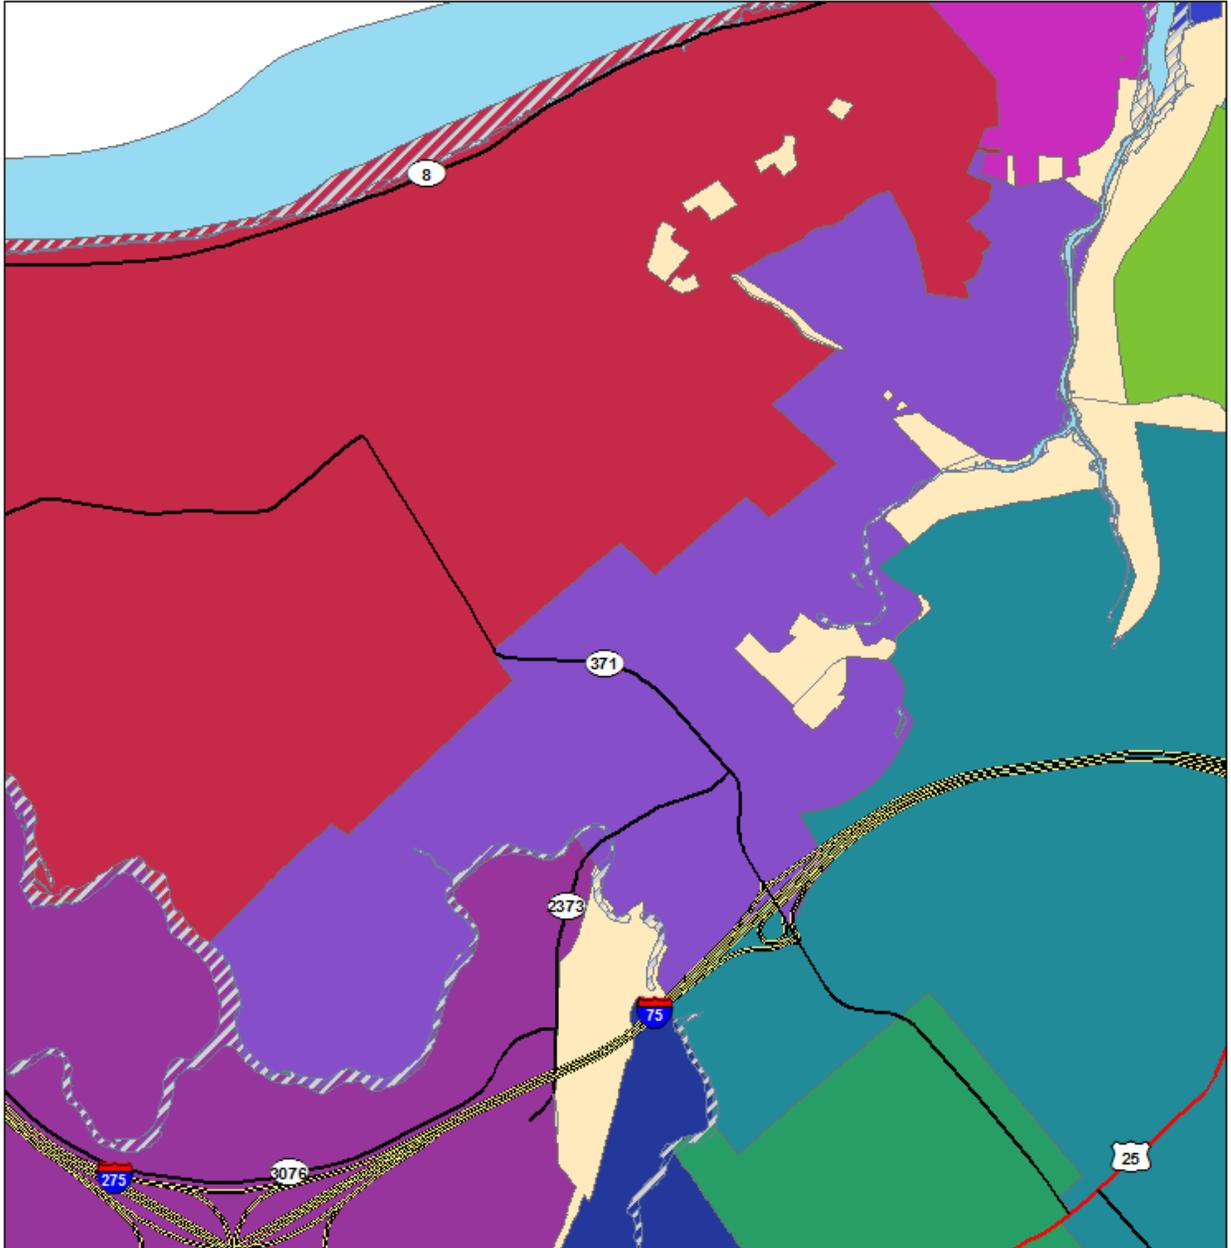
City of Crescent Springs Flood Hazard Area

- County Roads
- Interstate
- KY Highway
- US Highway
- Flood Hazard Area
- 0.2% Annual Chance Flood Hazard
- Reduced Flood Risk Due to Levee
- Floodway

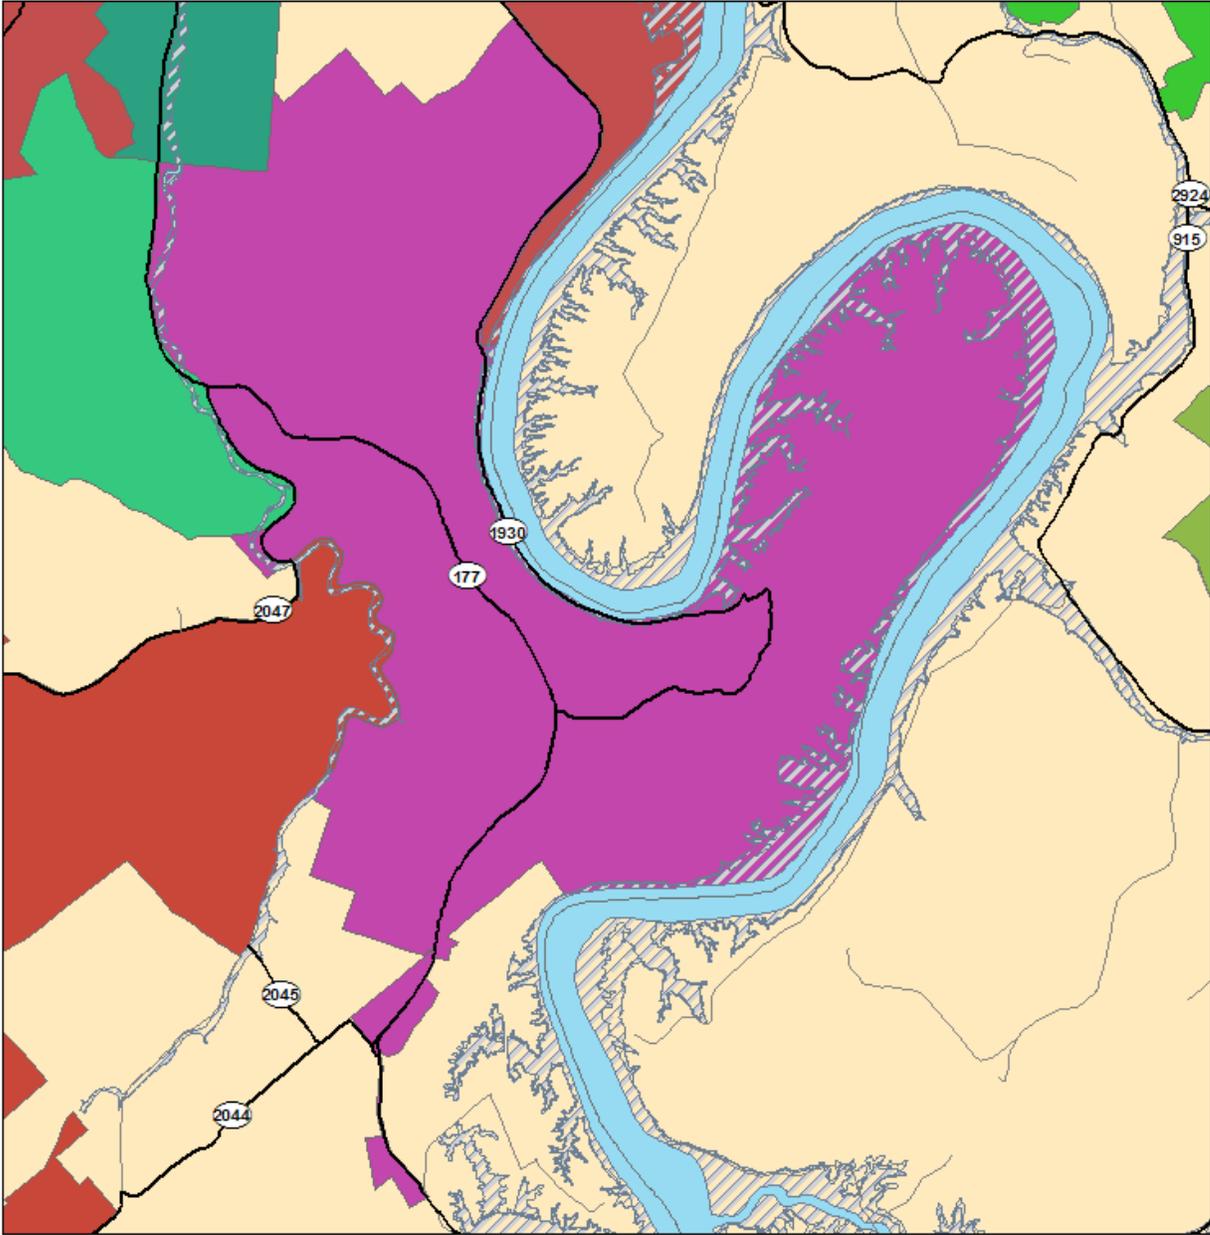
City of Ryland Heights Flood Hazard Area

- County Roads
- Interstate
- KY Highway
- US Highway
- Flood Hazard Area
- 0.2% Annual Chance Flood Hazard
- Reduced Flood Risk Due to Levee
- Floodway

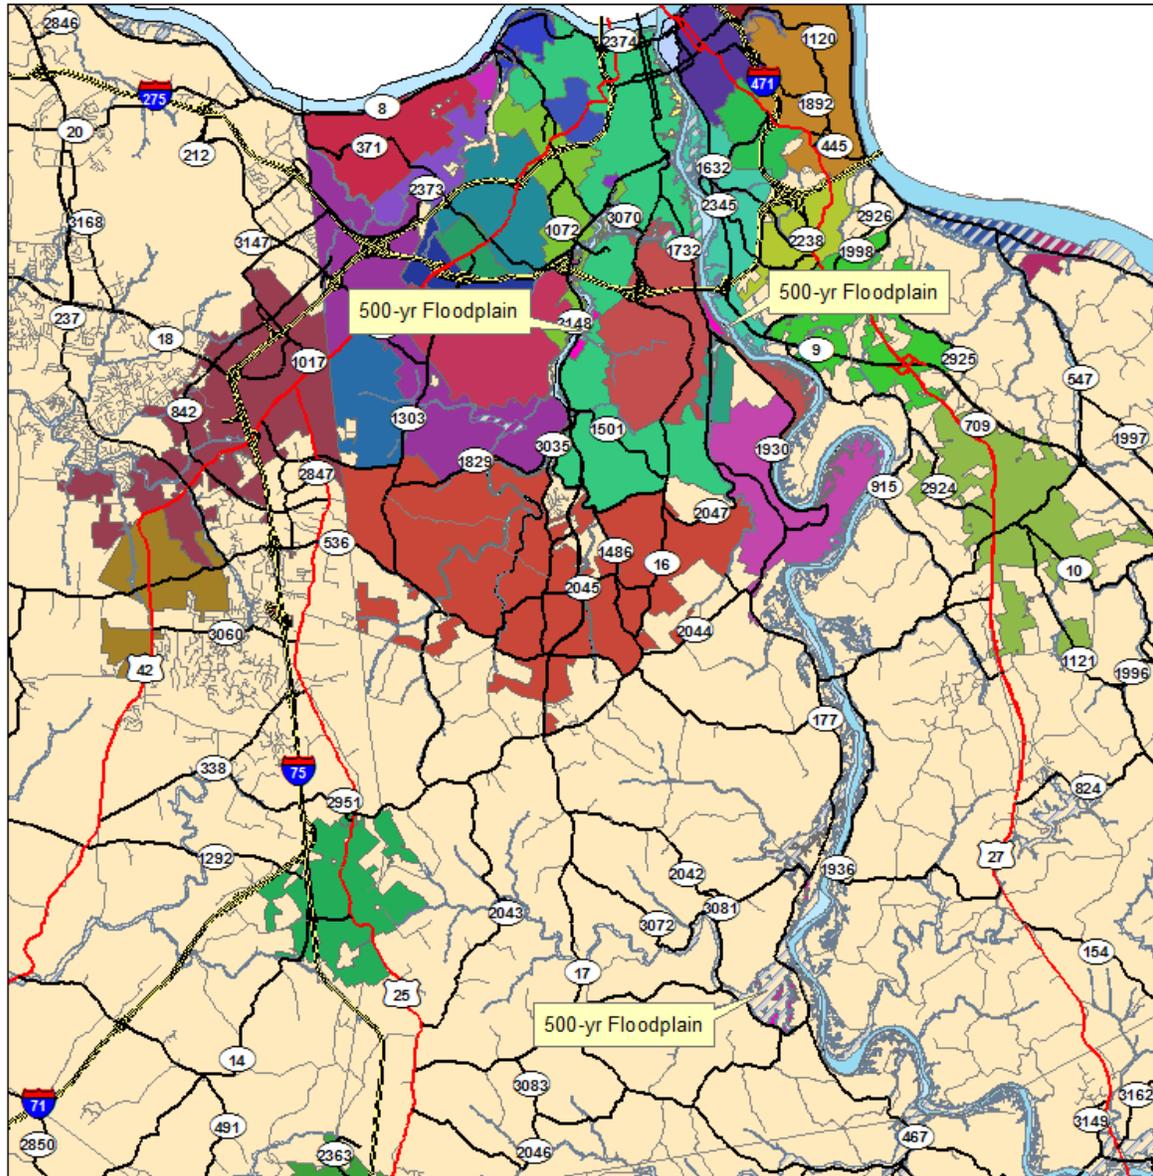
Kenton County 500 Year Floodplain

The map below shows the estimated 500-year floodplain, where there is a 0.2% annual chance of a flood. While there is not much difference between the 500-year and 100-year floodplain, there are some areas that will be affected by a larger historic event. It is important to keep in mind that this map does not include flash flooding, where many problems can be anticipated from such an historic event that would cause a 500-year flood.

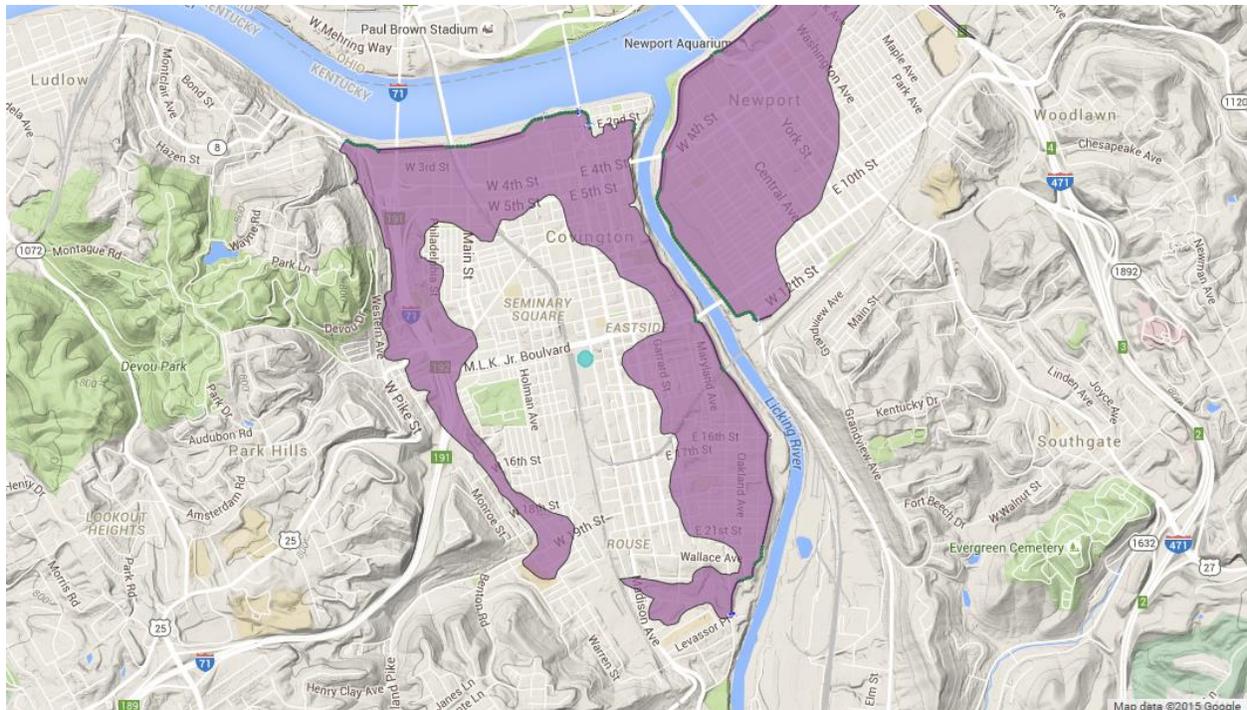
Covington Leveed Area (USACE, National Levee Database):

There is 1 levee in Kenton County, along the Ohio River in the City of Covington. According to the US Army Corps of Engineers National Levee Database it is 1.91 miles long, is designed for a 500 year flood with 3 feet of freeboard. The levee construction was completed in 1955. Its last routine inspection date was March 21, 2013 and it was found minimally acceptable. The leveed area is over 666 acres.

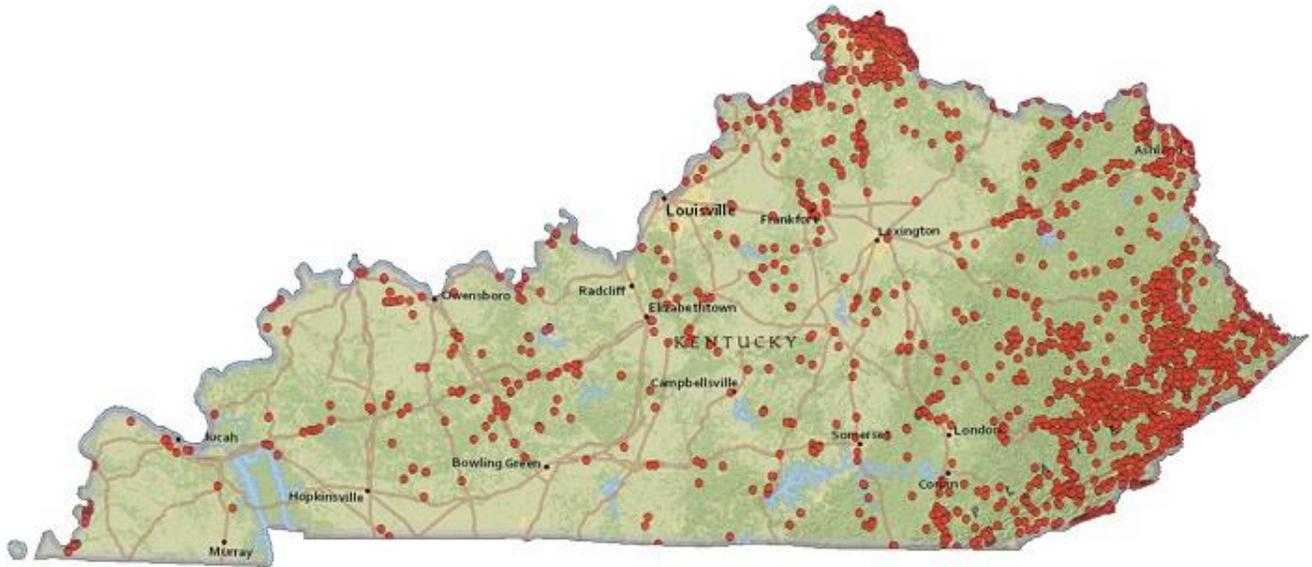
The map below is from the Kentucky Geological Survey’s website and depicts selected locations of landslides. The Northern Kentucky region experiences a vast amount of landslides compared to the rest of the state, particularly when taking into account that the eastern region that experiences numerous landslides also has mines. From the KGS website on the map below: “Selected known landslides in Kentucky. Although exact costs are not documented, landslides affect roads, buildings, pipelines, private residences, and other parts of the built environment. Direct costs such as repair and maintenance exceed \$10 million per year, and indirect costs may exceed direct costs but are difficult to quantify. With a good landslide inventory, citizens can begin to understand landslide processes, assess risk, and prevent damage from the threats they pose.”

Source: Kentucky Geological Survey, University of Kentucky, <http://www.uky.edu/KGS/geologic hazards/landslide.htm>, last modified 9/18/2015, collected 10/22/2015.

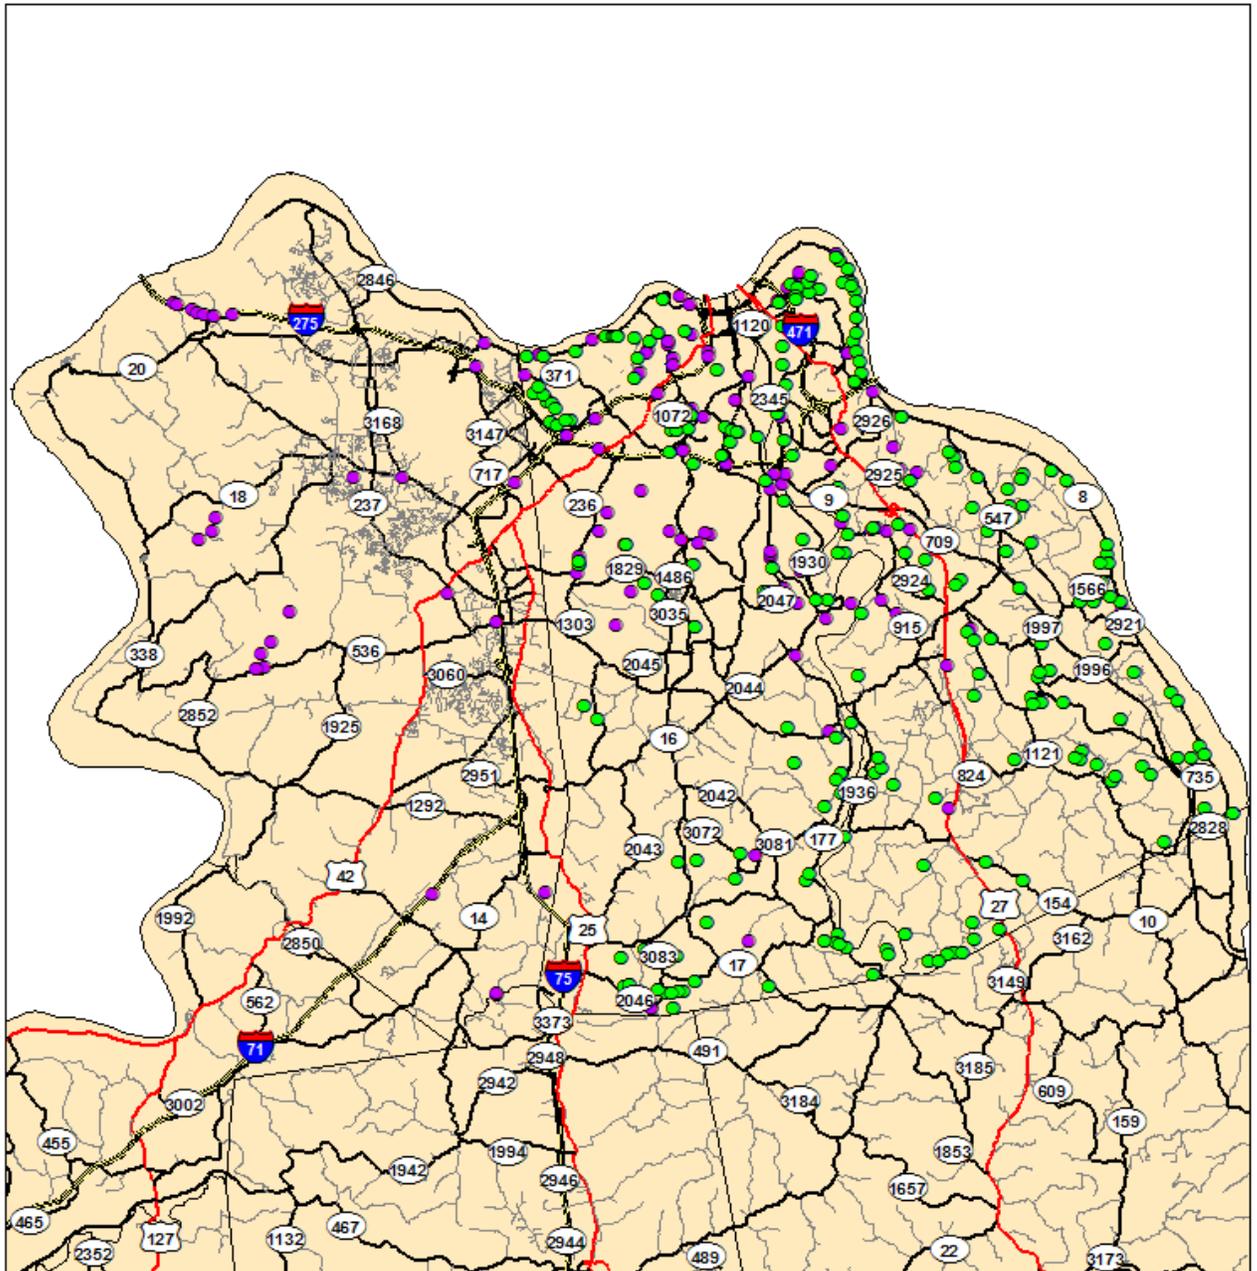
Boone, Kenton, Campbell Landslide Events, Past & Predicted

The Landslide map below shows past and predicted events that Sanitation District No. 1 tracks. This information comes from KYTC, PDSKC (formerly NKAPC), KGS, and other sources. Sanitation District No. 1's jurisdiction only covers Boone, Kenton and Campbell counties, which is why our information is very limited. However, the other counties have generally similar soils and topographies, so we can estimate that they experience the same issues. The Predicted Events are areas that SD1 has observed are susceptible to landslides.

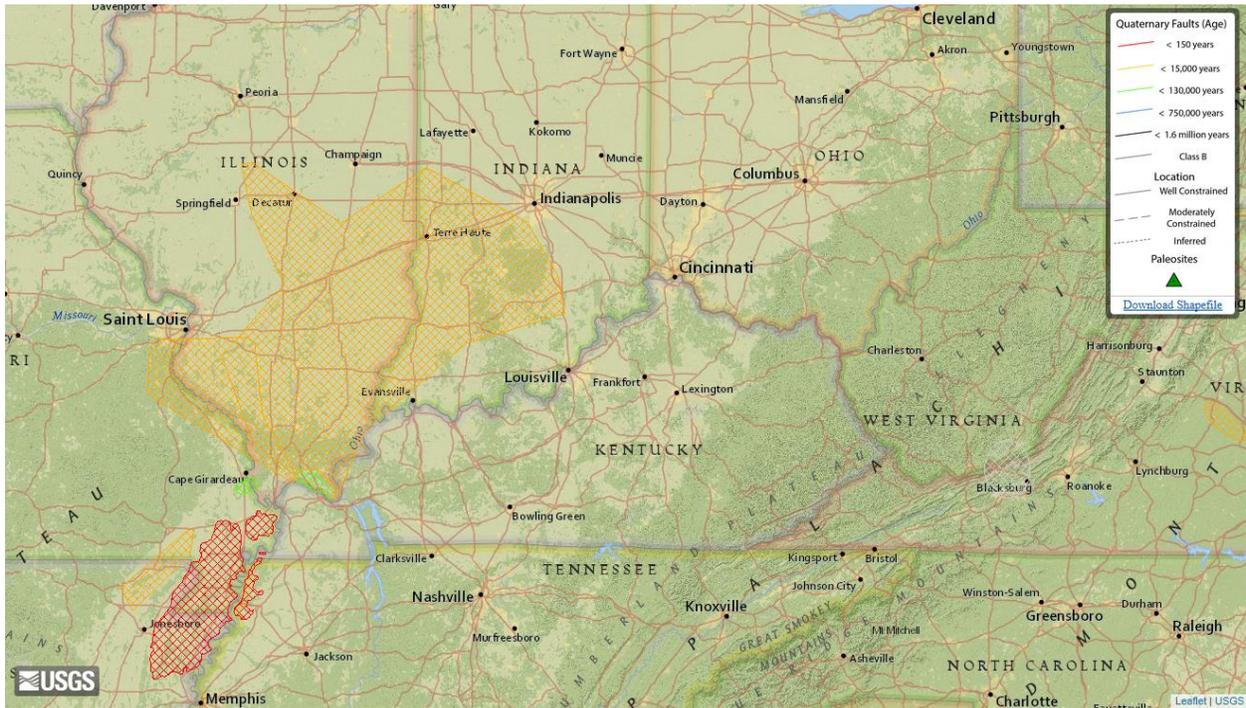
USGS Interactive Fault Map, Collected 10/28/2015. The orange area is the Wabash Valley liquefaction. The red area is the New Madrid seismic zone. The bright green areas are the Fluorspar Area fault complex and the Thebes Gap faults.

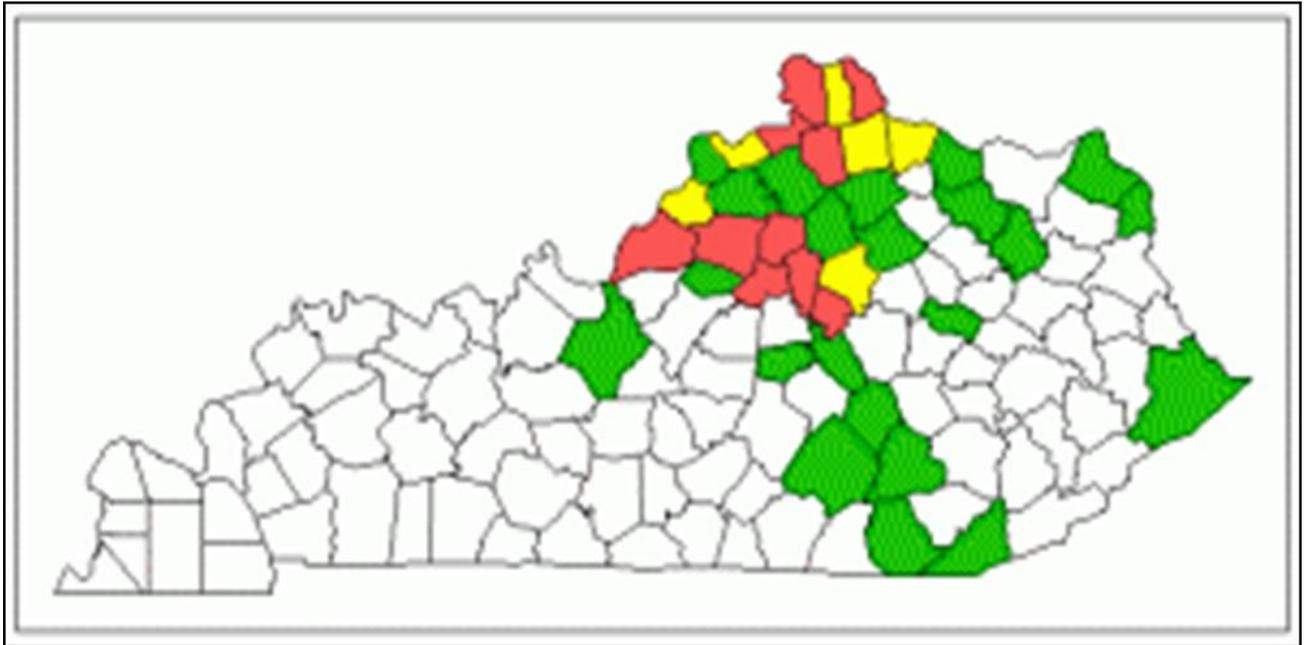
Red is high infestation, yellow is moderate and green is low.

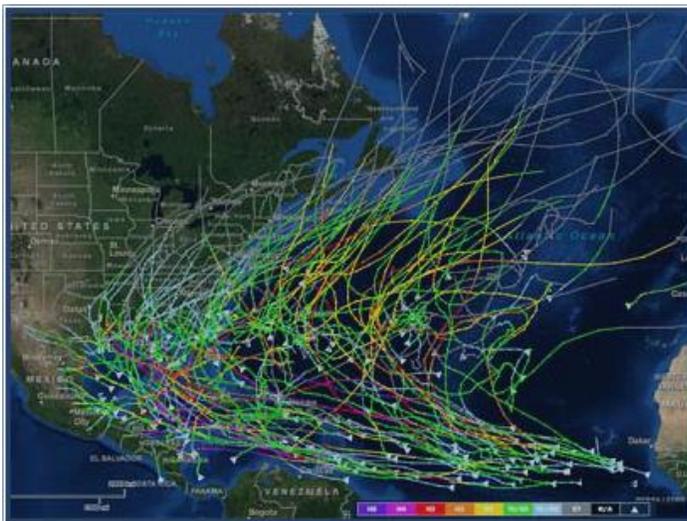
This graphic illustrates the path of hurricanes and major storms from 2000-2008. Beginning in the mid-Atlantic, most storms approach the southeastern US where they either make landfall or veer east into the upper Atlantic without affecting land masses. Although the most severe effects are experienced on coastal regions, inland areas also experience hazards related to hurricanes.

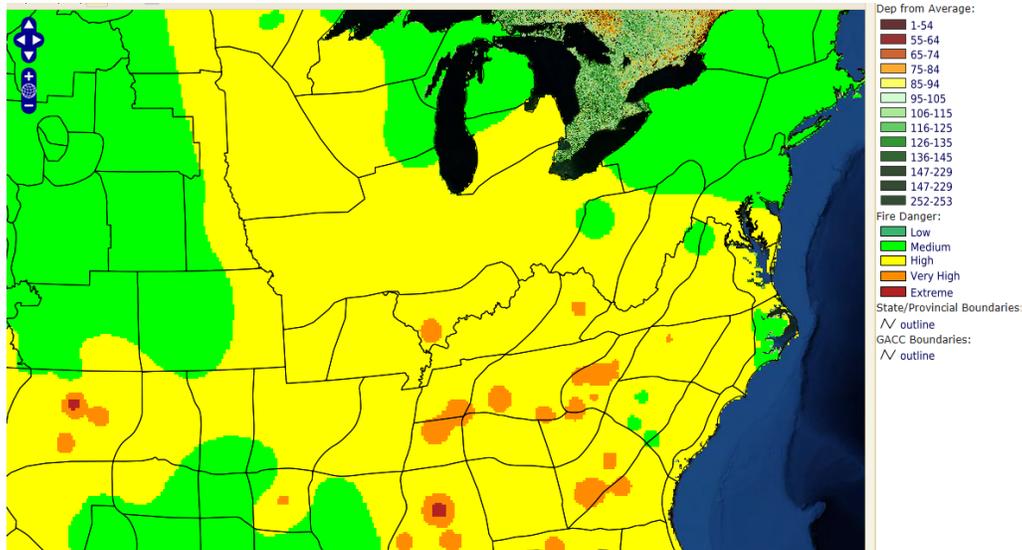
As seen in the map below, wildfires can occur in essentially any rural setting. In urban settings, there is typically not enough vegetation for a fire to spread. The Northern Kentucky area currently has a 'High' Fire Danger according to the Wildland Fire Assessment System interactive map (below). Due to the proximity of the rural counties in our area to even more rural and wooded areas, the risk of wildfires is markedly increased. In November 2016, there are wildfires throughout Eastern Kentucky and according to some local news sources, smoke could be detected in Pendleton County, even though the wildfires had not yet entered the county. Additionally, a drought has been declared for all Kentucky counties except for Boone, Kenton and Campbell. Drought is a major catalyst for wildfires.
